No. 355

EFFECT OF THE ANGULAR POSITION  
OF THE SECTION OF A RING COWLING ON THE HIGH SPEED  
OF AN XF7C-1 AIRPLANE

By Melvin N. Gough

Washington  
November, 1930

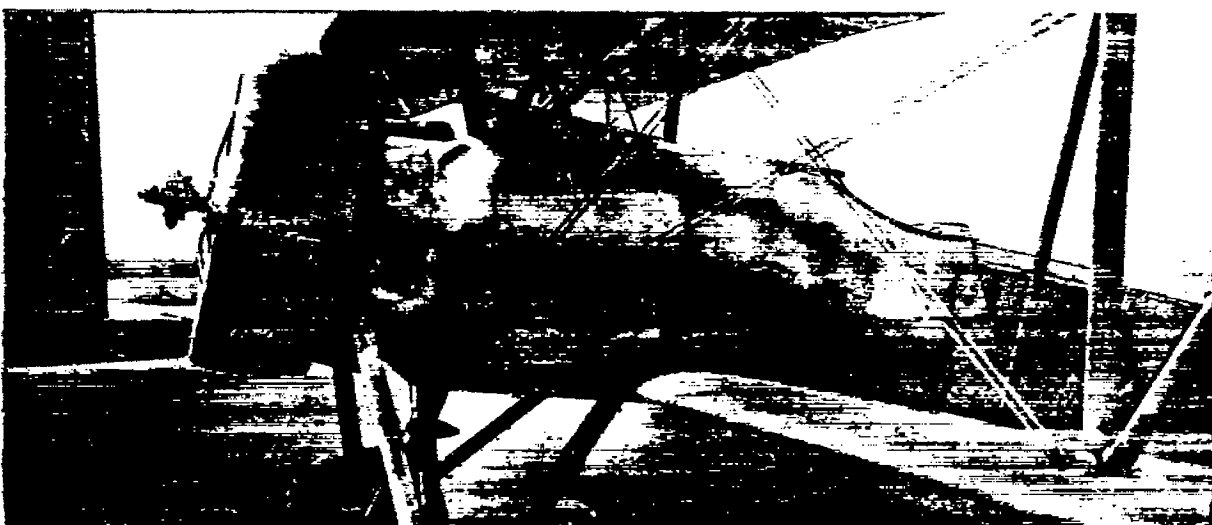
Figs.6,7,8 Views of cowling set at  $-4.7$  degrees on fuselage No.2.

The fuselage lines at the nose were modified as shown in Figure 2. Front, three-quarter front, and side views of the variable angle cowling set at  $-4.7$  degrees on the XF7C-1 airplane with service fuselage (No. 1) are shown in Figures 3, 4, and 5. For comparison, Figures 6, 7, and 8 are shown with the cowling at  $-4.7$  degrees on No. 2 fuselage. Figure 9 is a side view of the cowling set at  $-8.8$  degrees on No. 3 fuselage. The manner and amount by which the angle of the cowling could be changed may be seen from Figures 10, 11, and 12, which are front, three-quarter front, and side views of the cowling set at  $-18.8$  degrees on No. 2 fuselage and Figure 13, which shows the cowling set at the other extreme,  $+6.4$  degrees, on No. 1 fuselage. A better idea of the No. 2 fuselage nose shape may be obtained from Figure 14. The vertical deflectors between the cylinders may be noticed and were used with No. 2 and No. 3 fuselages.

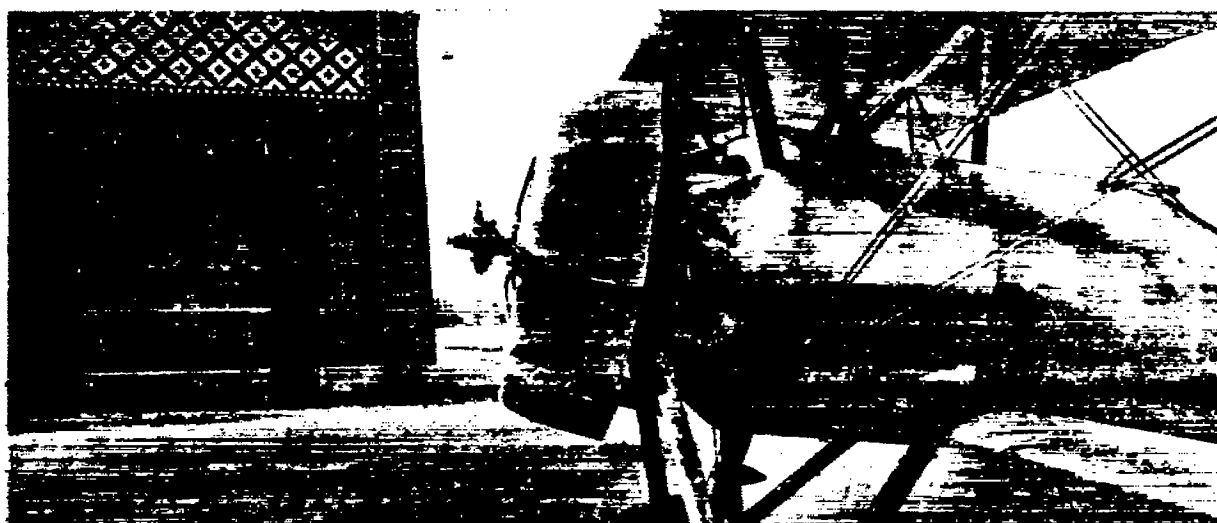
Figs.10,11,12 Views of cowling set at  $-18.8$  degrees on fuselage No.2.
